1 REPORT NO. CA-DOT-TL-3324-1-76-14		2 GOVERNMENT ACCESSION NO.		3 RECIPIENT'S CATALOG NO.	
4 TITLE AND SUBTITLE A REVIEW OF THE PERFORMANCE OF LIME TREATED ROADWAYS IN CALIFORNIA				5 REPORT DATE April 1976	
				6 PERFORMING ORGANIZATION CODE	
7 AUTHOR(S) Max L. Alexander				8 PERFORMING ORGANIZATION REPORT NO. 19303-633324	
9 PERFORMING ORGANIZATION NAME AND ADDRESS Office of Transportation Laboratory California Department of Transportation Sacramento, California 95819				10 WORK UNIT NO.	
				11 CONTRACT OR GRANT NO. D-2-14	
12 SPONSORING AGENCY NAME AND ADDRESS California Department of Transportation Sacramento, California 95807				13 TYPE OF REPORT & PERIOD COVERED Final	
				14 SPONSORING AGENCY CODE	
15 SUPPLEMENTARY NOTES This study was conducted in cooperation with the U.S. Department of Transportation, Federal Highway Administration.					
16 ABSTRACT A review was made of the pavement condition of roadways constructed with lime treated soils and aggregates throughout California. This review, in conjunction with detailed investigations of selected roadways, was used to evaluate the performance of lime treated materials when incorporated into the roadway structural section.

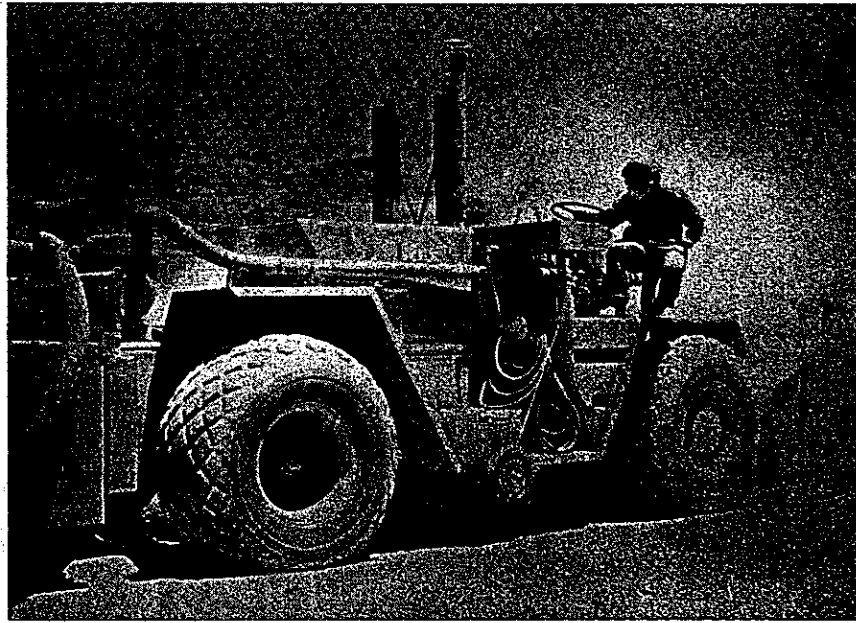
As mentioned in the following section on Construction Methods and Equipment, the finely ground hydrated limes tend to be difficult to discharge uniformly from distribution equipment. In addition, dust is often a matter of considerable concern

during both the distribution and mixing of these products. There have, in fact, been occasions when construction has been shut down because of the amount of lime dust in the air.

Figure 10
Dust Problem with Finely Ground Lime

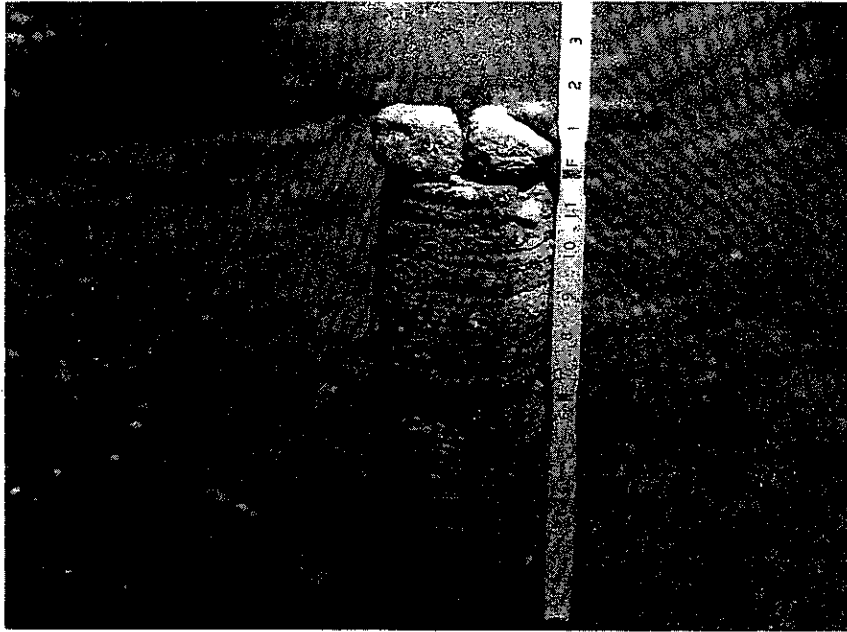
This separation on compaction planes has also been observed in laboratory compacted test specimens. One load application of the kneading compactor as the test material is being built up in the compaction mold is often enough to create a poorly bonded compaction plane (see Figure 17).

There is insufficient data to estimate how much the strength of a well cemented lime treated material would be reduced by the lack of bonding between layers. It is certain, however, that the load carrying capacity of the road would depend directly on the strength and position of the poorest quality lime treated material in a nonuniform layer. Also, the lack of composite action by the subbase or base will decrease the load carrying capacity of the structural section to some degree. For these reasons it is recommended that the maximum lift thickness for lime treated soils be increased to 12 inches and that a minimum lift thickness of 4 inches be added to the specifications. Uniform distribution of the lime and adequate compaction are essential, however, and authorization to mix and compact thicknesses greater than 6 inches should be subject to the judgement of the Engineer and the contractor's ability to comply with all the other specification requirements.

Figure 16
Construction Planes in Lime Treated Soil

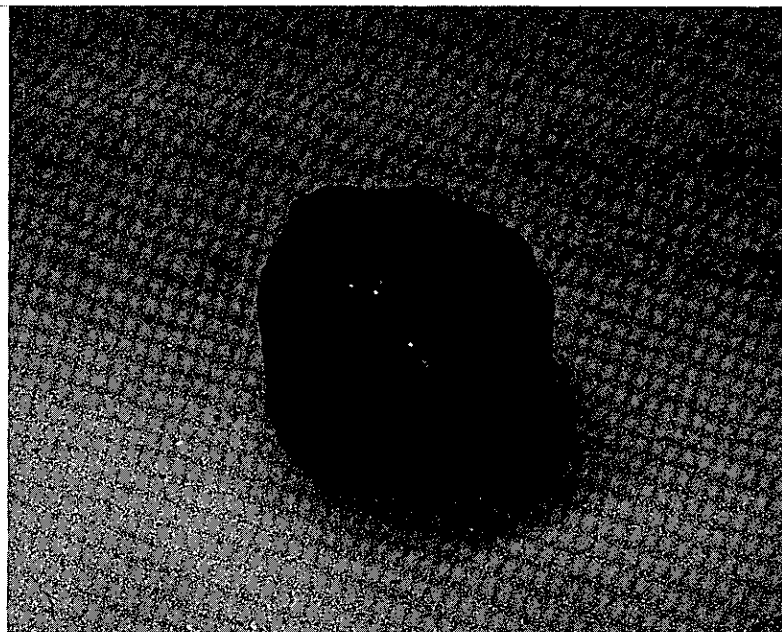
Figure 17
Compaction Planes in Laboratory Test Specimen

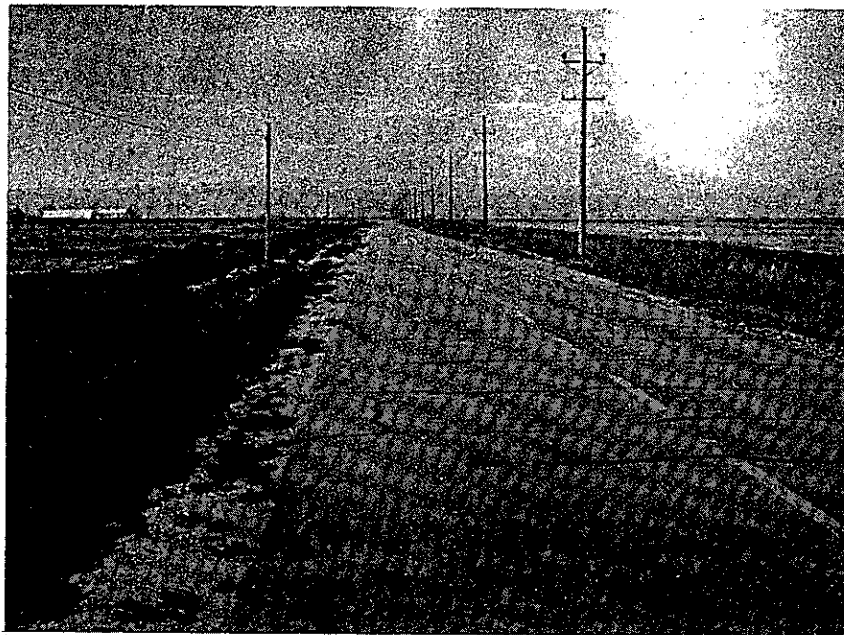
Transverse cracking of the type normally associated with slab shrinkage was observed in the asphalt concrete surfacing of many of the lime treated roadways reviewed in this study (see Figure 18). Both treated soils and treated aggregates were so affected but the chances of this type of cracking occurring seemed to be greater on projects where lime was used to treat

the more granular materials. Sixty percent of the roads constructed with lime treated aggregates showed evidence of shrinkage cracking compared to only twenty percent of the roads constructed with lime treated soils. Also, all of the roads which had visible shrinkage cracking were in fair to good condition after ten years of service. Only one of these had required resurfacing other than planned stage construction prior to the end of ten years. Evidently, the lime treated materials which had visible shrinkage cracking generally provided a stronger structural section (slab effect) than other lime treated materials which were not as susceptible to shrinkage cracking.

Figure 18
Shrinkage Cracking

These observations tend to substantiate previous conclusions by other researchers (8) that shrinkage type cracking on lime stabilized projects occurs most often when the treated base consists of low PI materials. It was theorized by McDowell that aggregate bearing mixtures consisting of high PI materials and lime are less fragile and can support loads with less cracking during curing than can low PI or more fragile mixtures.

6. Lime Treated materials must be protected from excessive drying. The surface of the compacted layer should be covered as soon as possible after compaction with the next layer of the structural section or a curing seal. When it becomes necessary to keep the surface of the lime treated material moist by the application of water, traffic should not be permitted on this moist material.

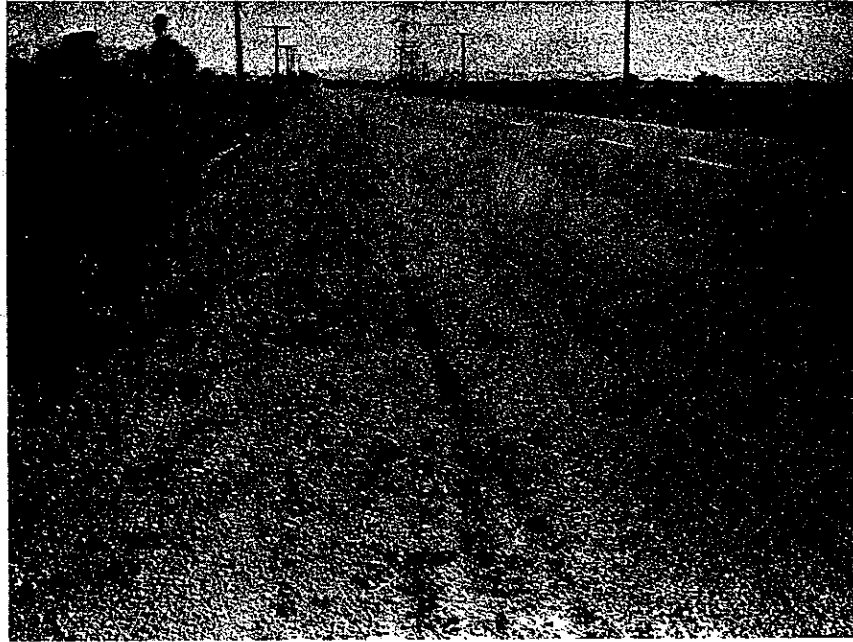
Figure 22
Pavement in Excellent Condition After Seven Years
